Final Phase II Environmental Site Assessment

Targeted Brownfields Assessments

Former Beech Nut Manufacturing
Facility

Canajoharie, New York

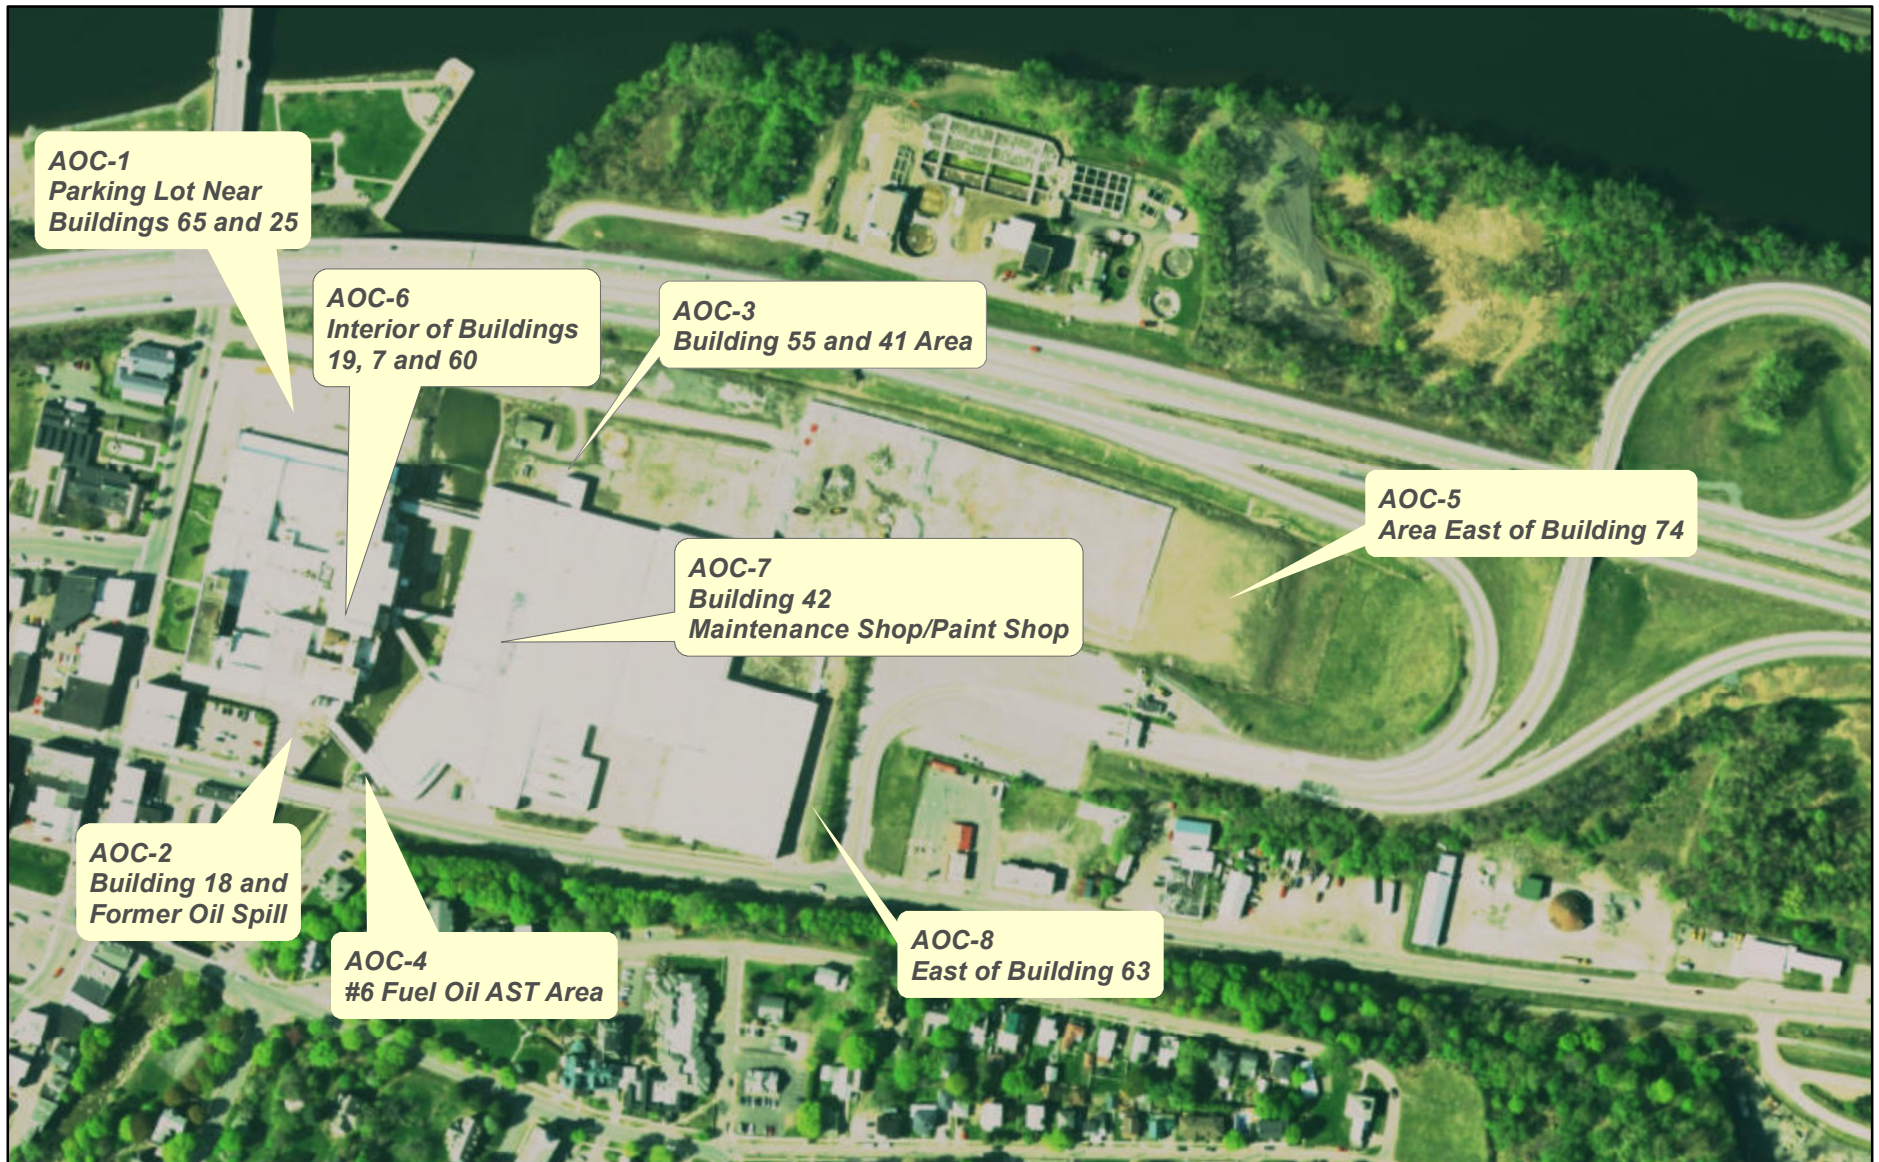
Figure 1-2
Canajoharie, NY

**Beech Nut Manufacturing Facility
Areas of Concern**

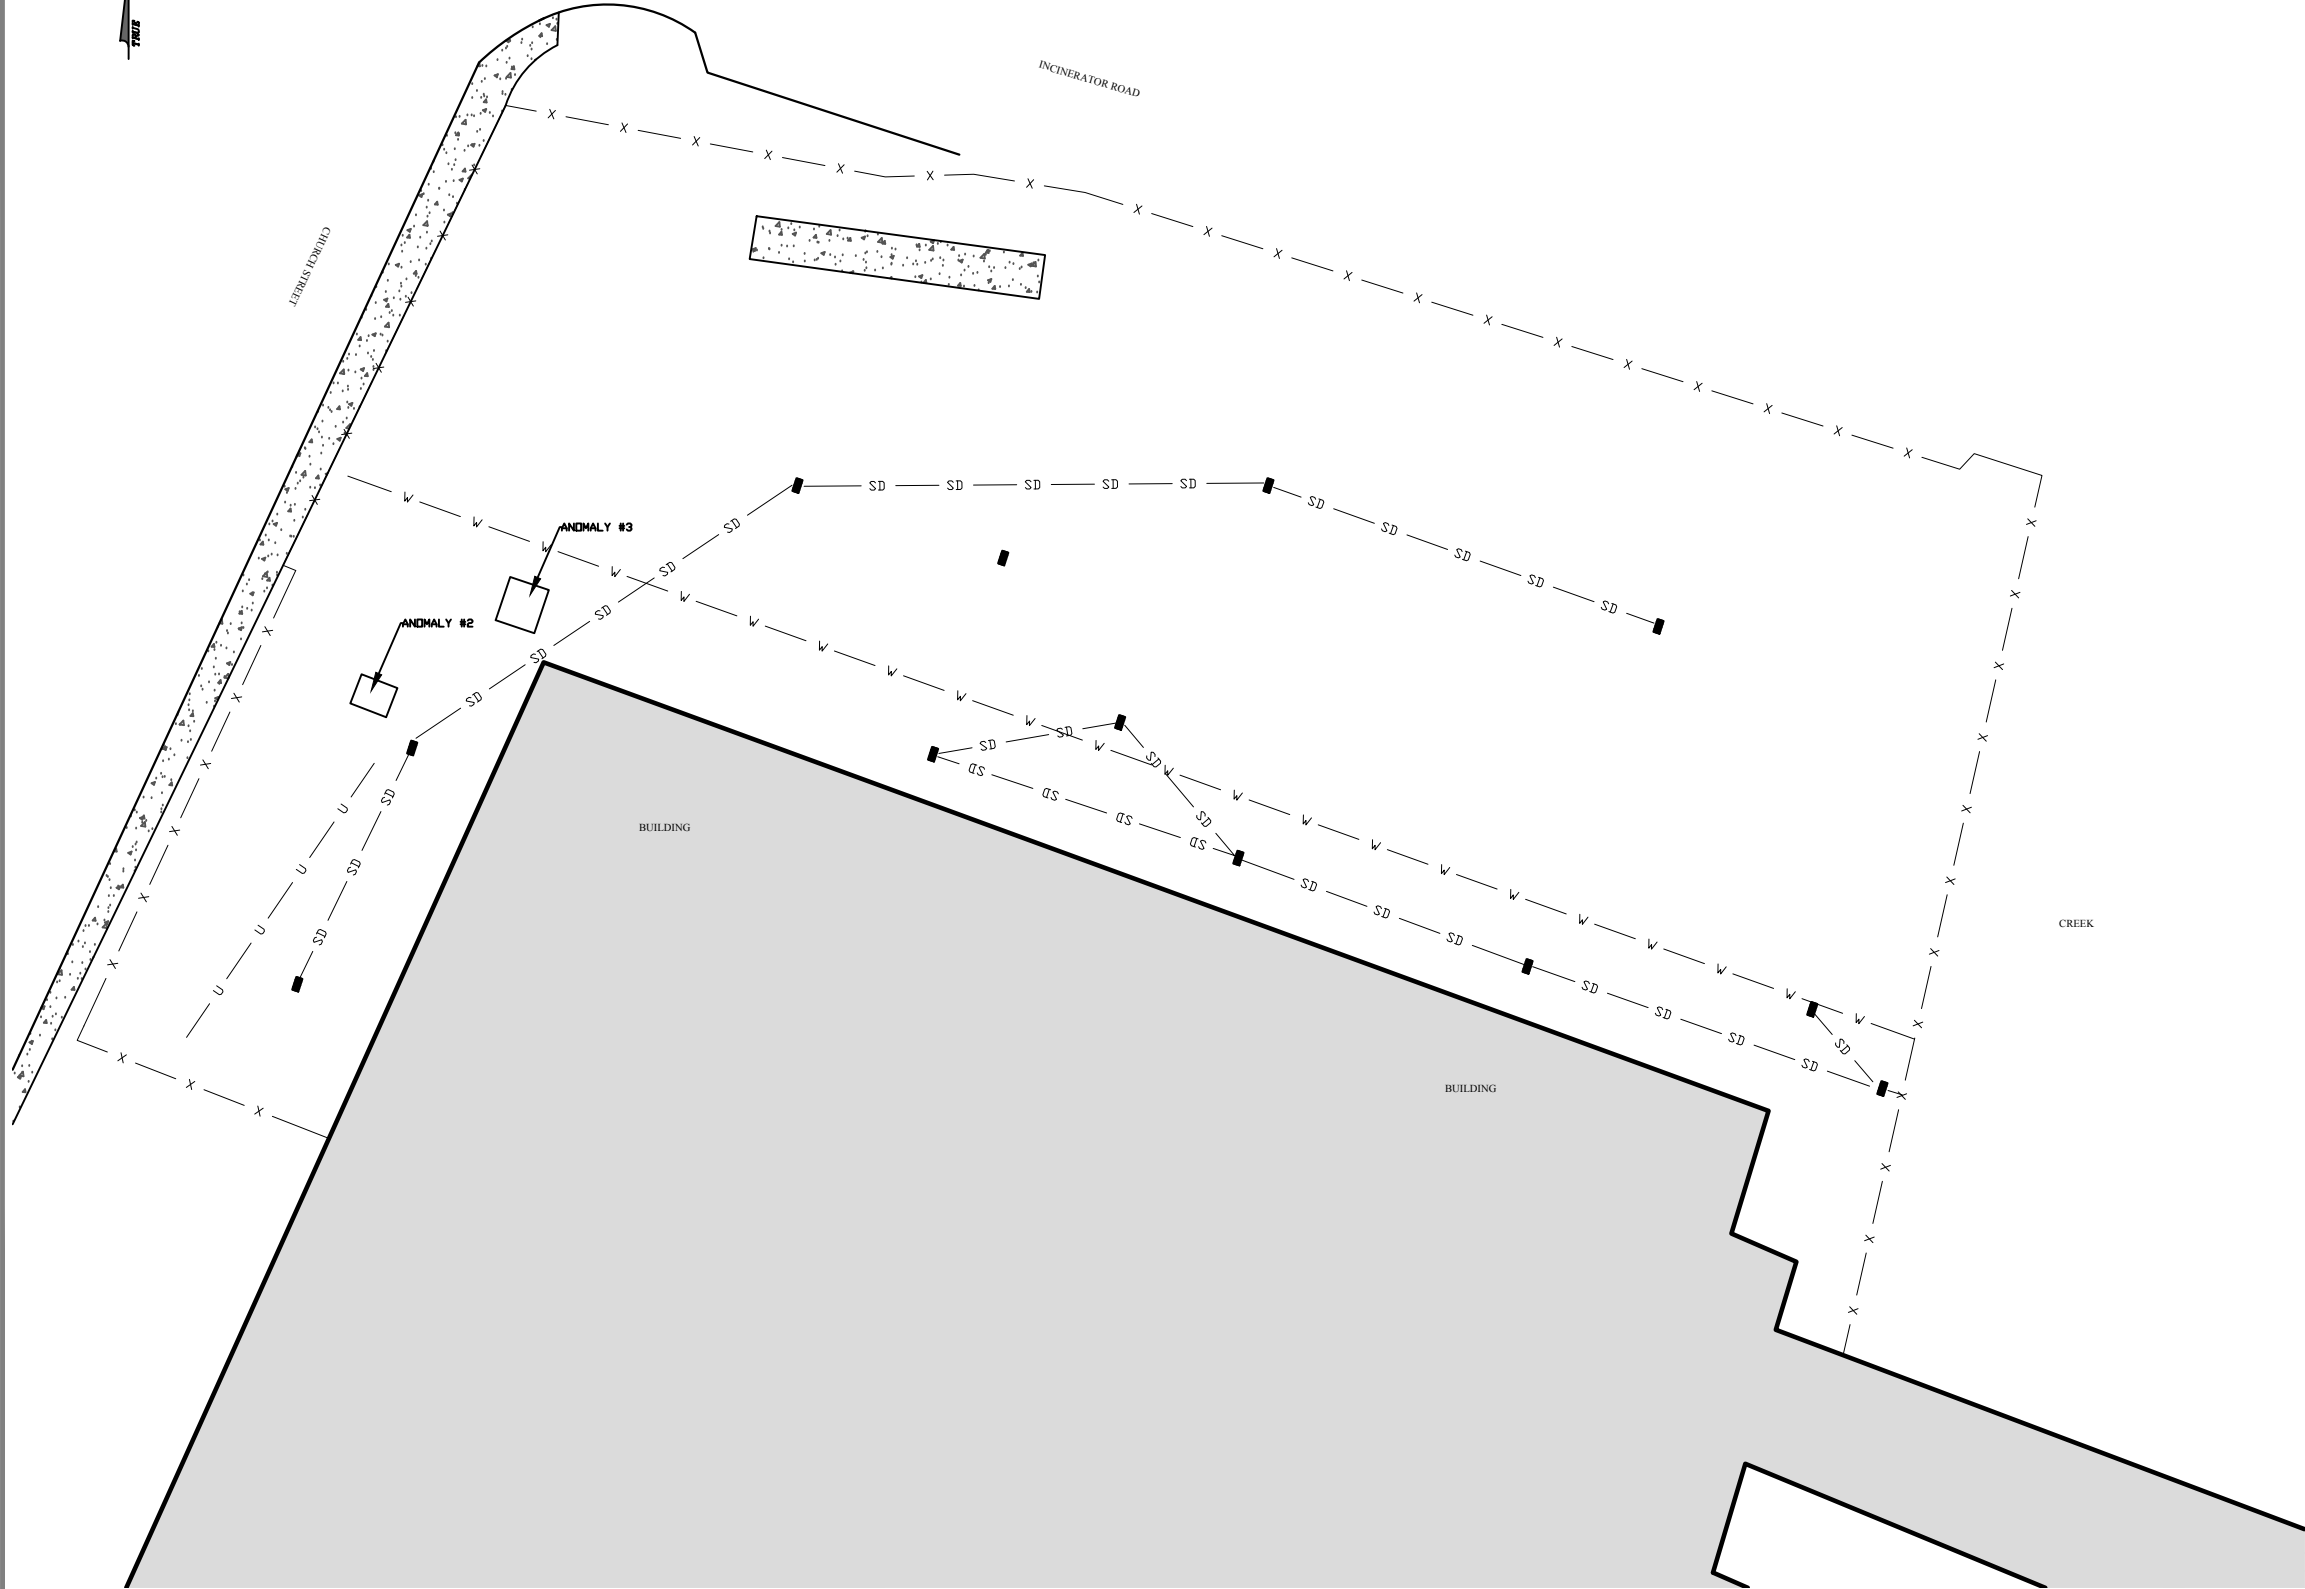
DATE	7/29/16
SCALE	1" = 40'
DWG NO.	072916-02
SHT NO.	2 OF 4
PROJECT	D071216

This site plan was produced from data collected by differential GPS measurements collected in the field. Due to the errors normally present in DGPS data, this document is not intended or represented to be of survey precision. Caution should be used in all field measurements based on this site plan.

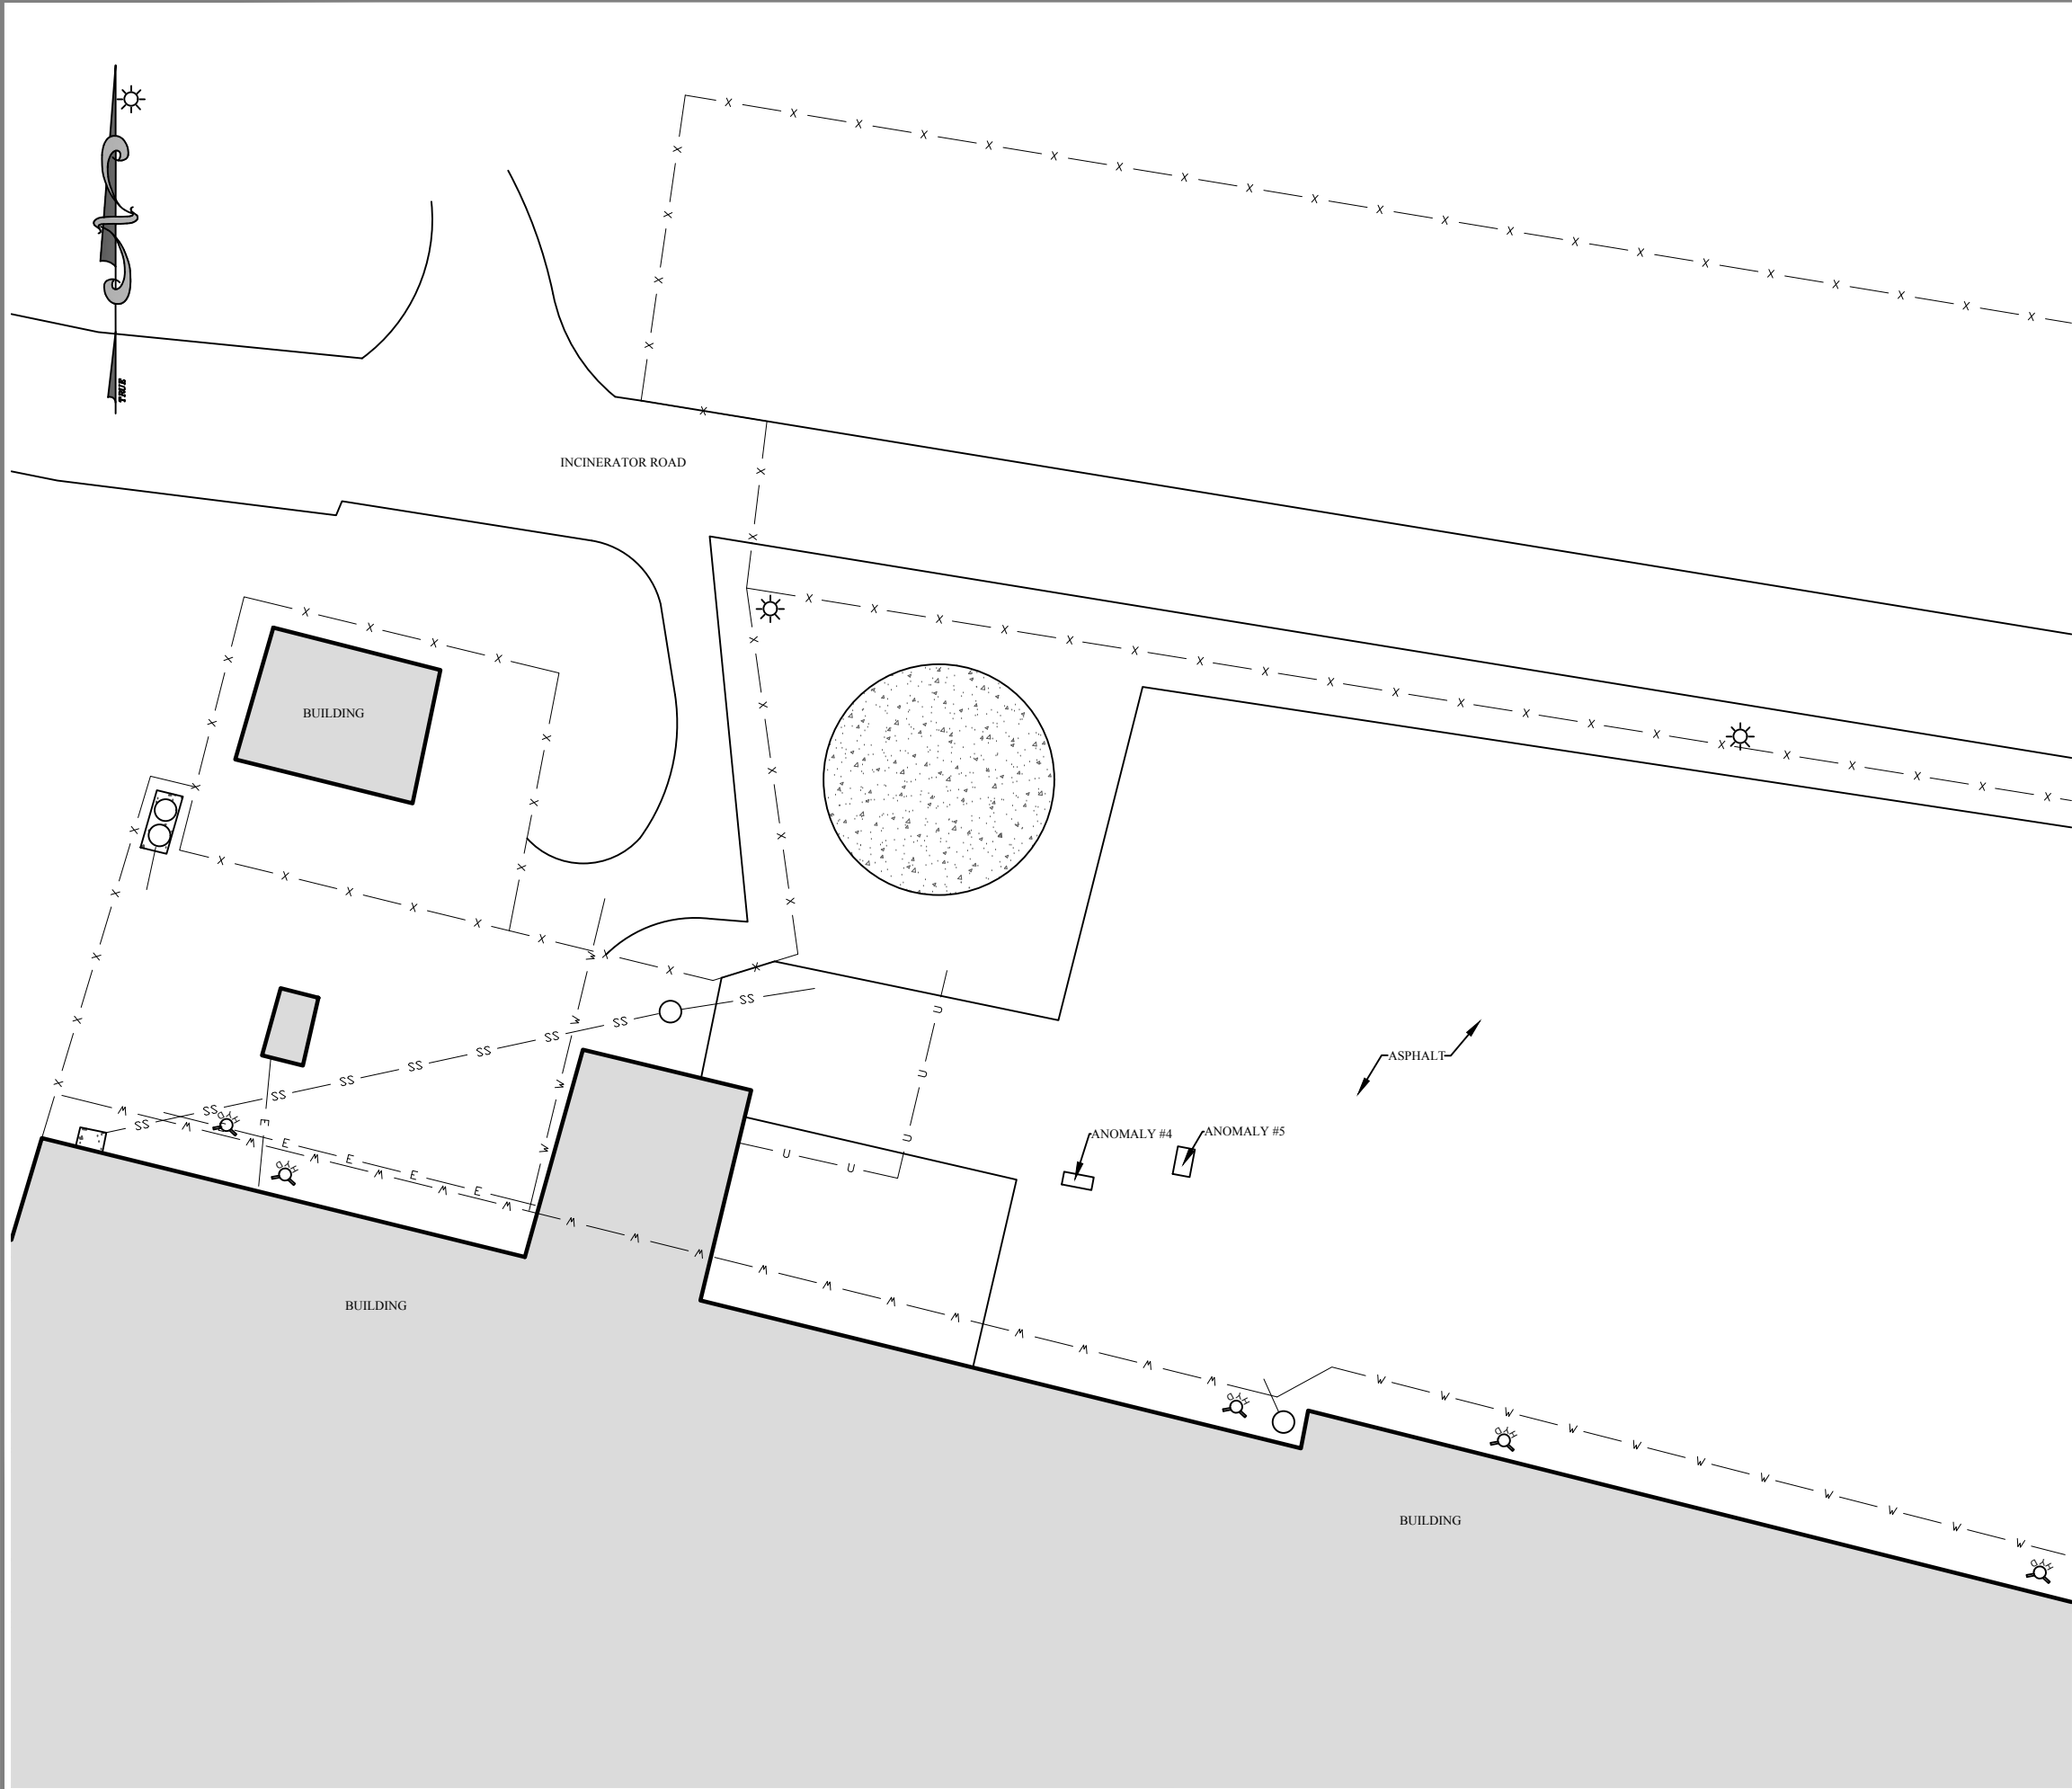
DATE	7/29/16
SCALE	1" = 40'
DWG NO.	072916-03
SHT NO.	3 OF 4
PROJECT	D071216

GEOPHYSICAL INVESTIGATION
68 CHURCH STREET, CANAJOHARIE, NEW YORK
FOR
CDM SMITH

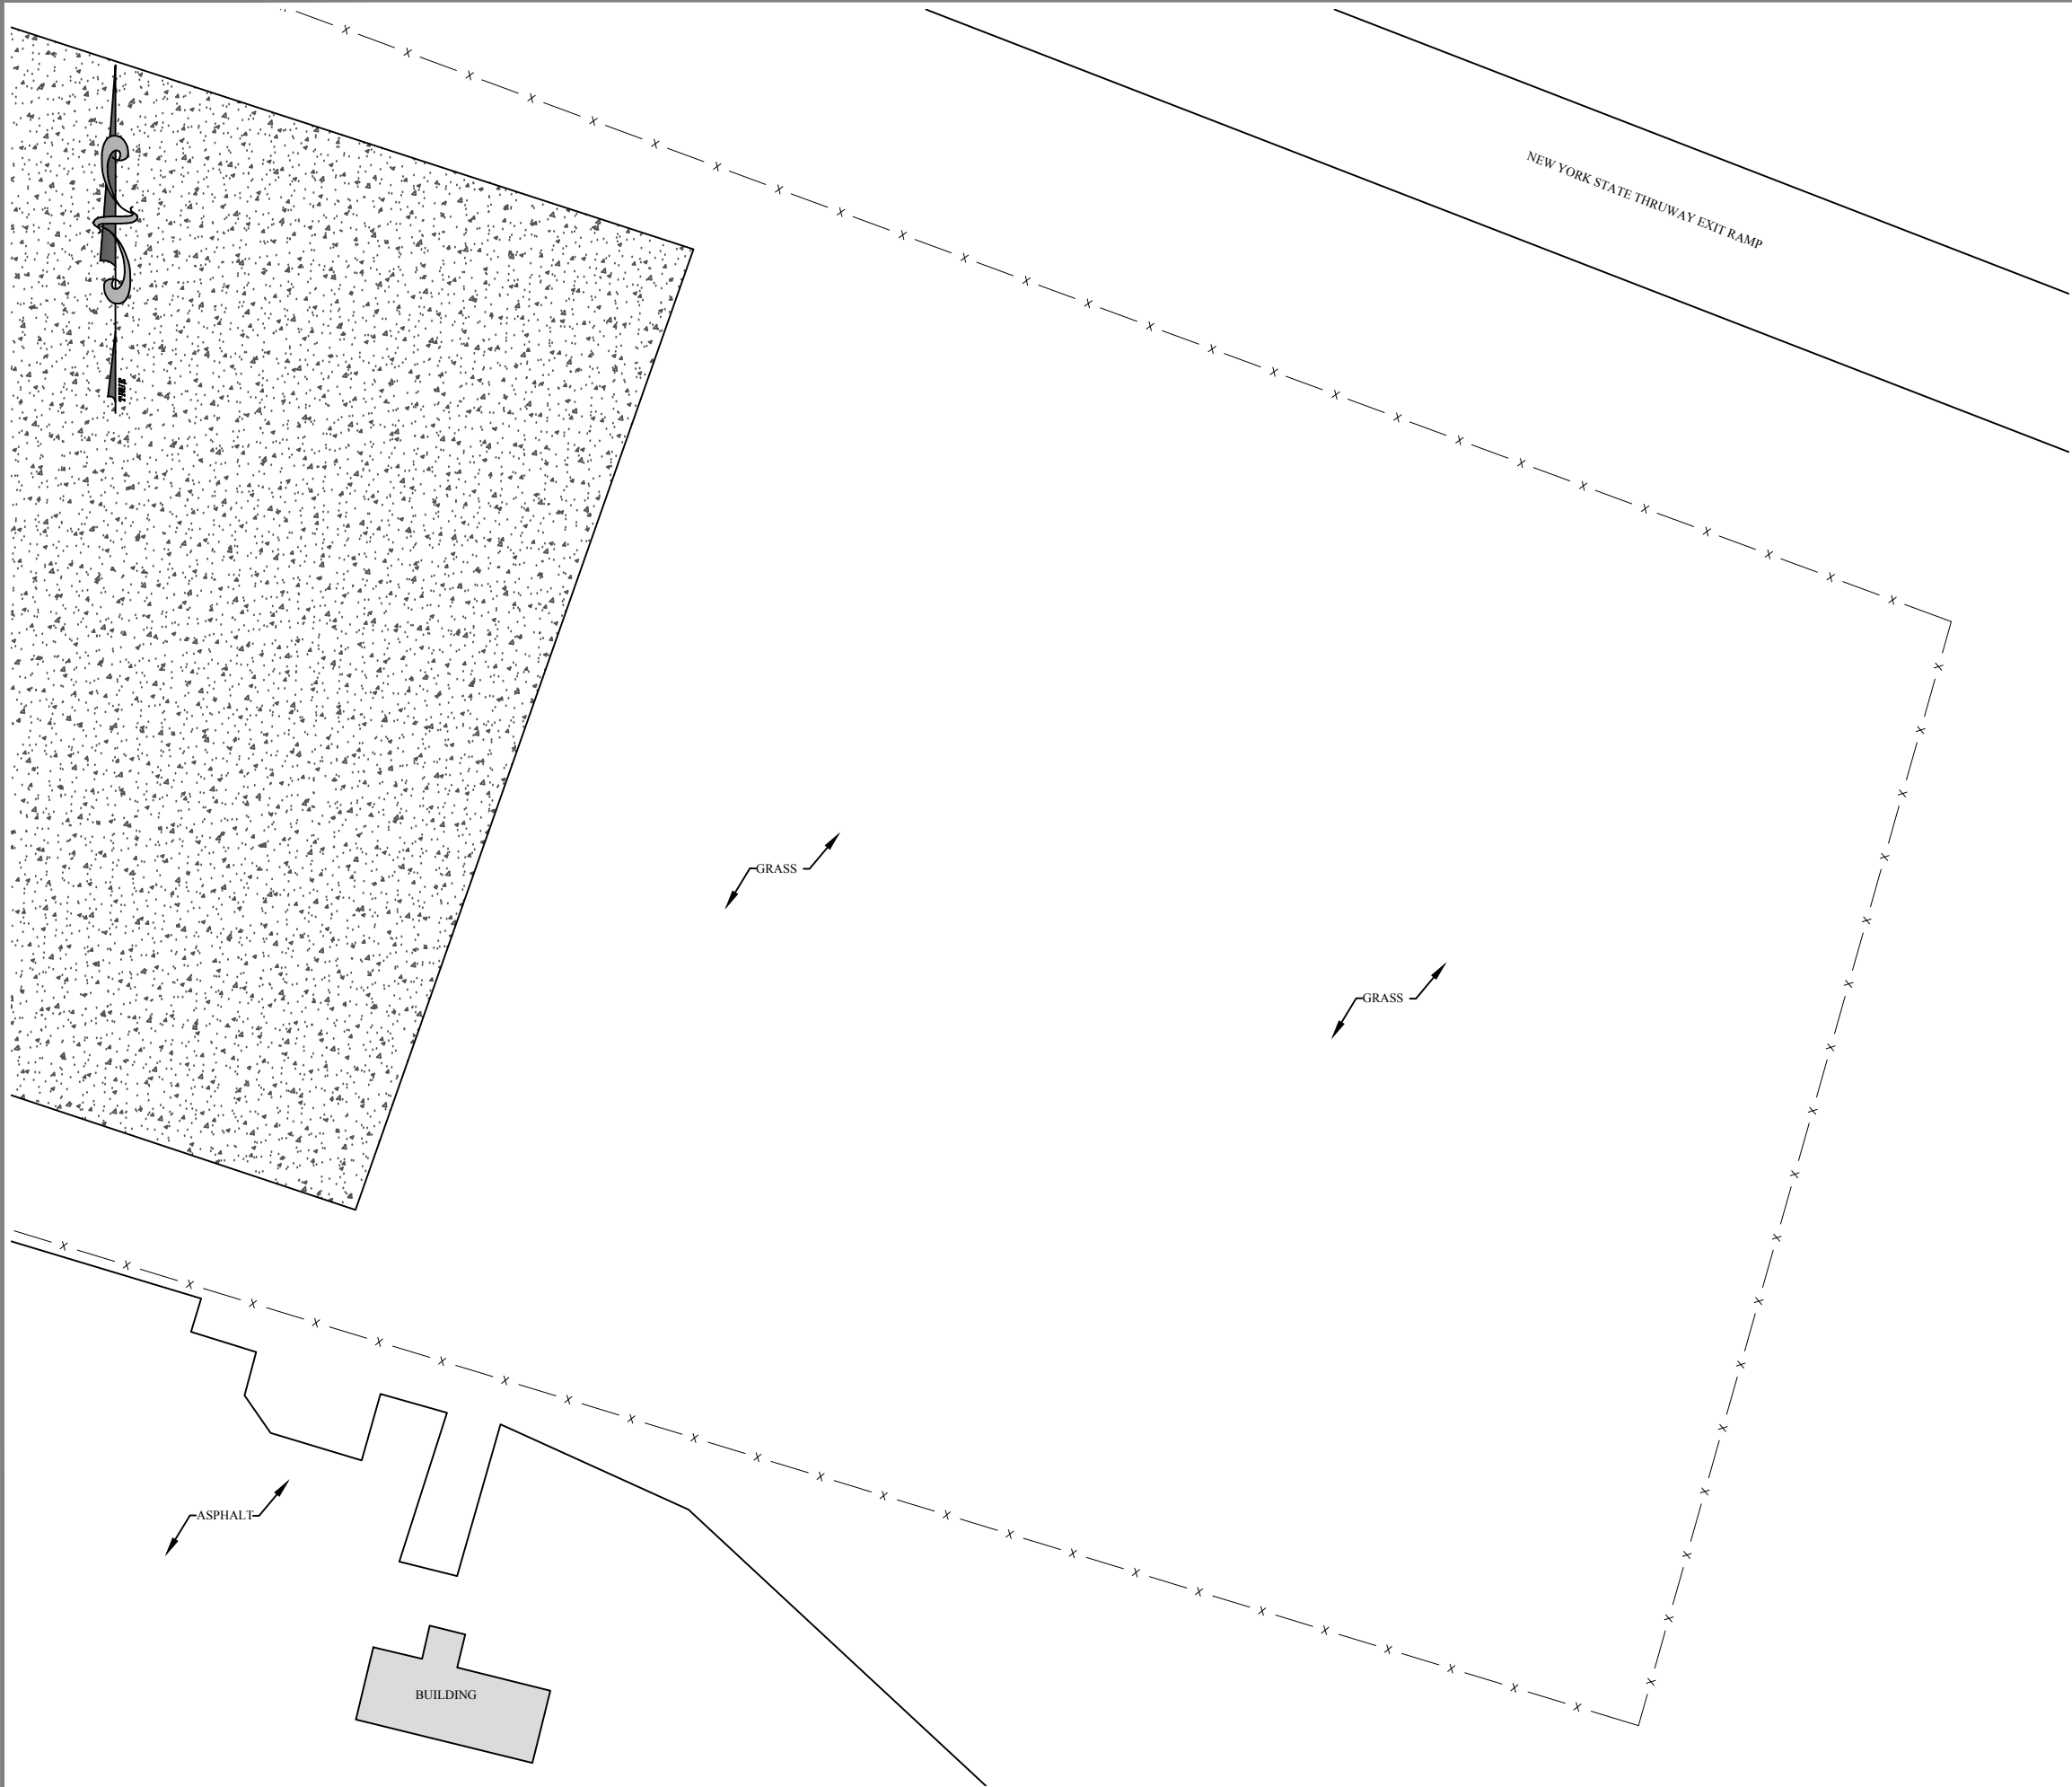
As with any geophysical method, it must be stressed that caution be used during any excavation or intrusive testing in proximity of any anomalies indicated in this plan. The anomalies are only indications of potential subsurface conditions and are not intended to be used as a basis for any construction or other engineering decisions. This site plan is based upon the application of scientific principles and professional judgment in certain facts with resultant subjective interpretations. Professional judgments expressed herein are based on the facts currently available within the limits of the existing data, scope of work, budget, and schedule.
